# THERMAL ANALYSIS

9661 CANYON LANDING AVE. 04/14/2025 1200hrs.

East roof-8 panel array

West roof- 9 panel array

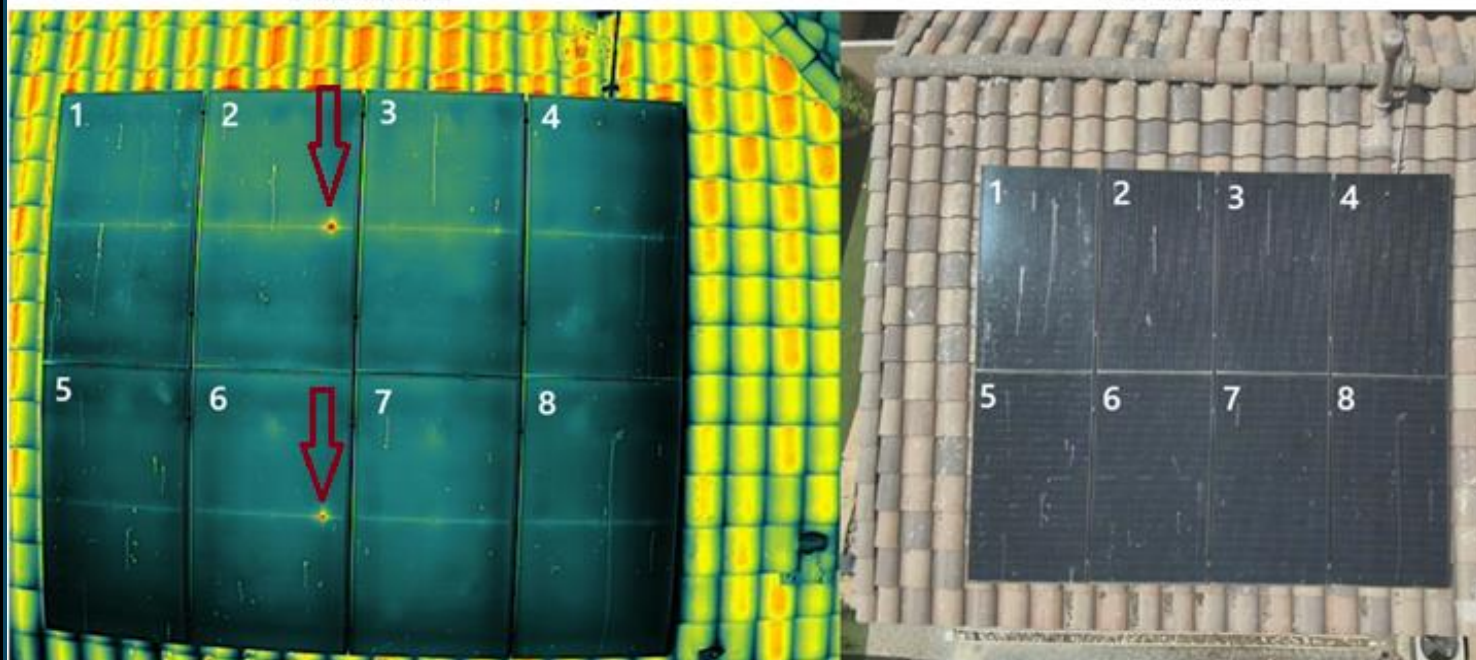
## EAST ROOF

Aerial thermographic analysis of the east roof panels shows 8 vertically oriented (likely Half Cut style) panels with no heat signatures indicating malfunctioning cells. Panels 2 and 6 exhibit a thermal anomaly along the center axis consistent with early signs of interconnect stress.

Possible causes of Midline Hot Spots in Half-Cut Panels:

### 1. Stressed Central Interconnect or Junction

- The central interconnect is where the current from the top and bottom halves of panel combine.
- A bad solder, microcrack, or loose tabbing ribbon here will increase resistance.
- That resistance = localized heat, even if the panel seems to be producing normally.

This is the most common cause of centerline hotspots in half-cut panels.

## 2. Lamination or EVA Voiding

- Heat right along the midline could also be from voids or bubbles in the encapsulant caused during manufacturing.
- This can trap heat and cause visible hot spots.

Re-image panels 2 and 6 in six months to see if increased heat in midline is effecting surrounding cells or not.

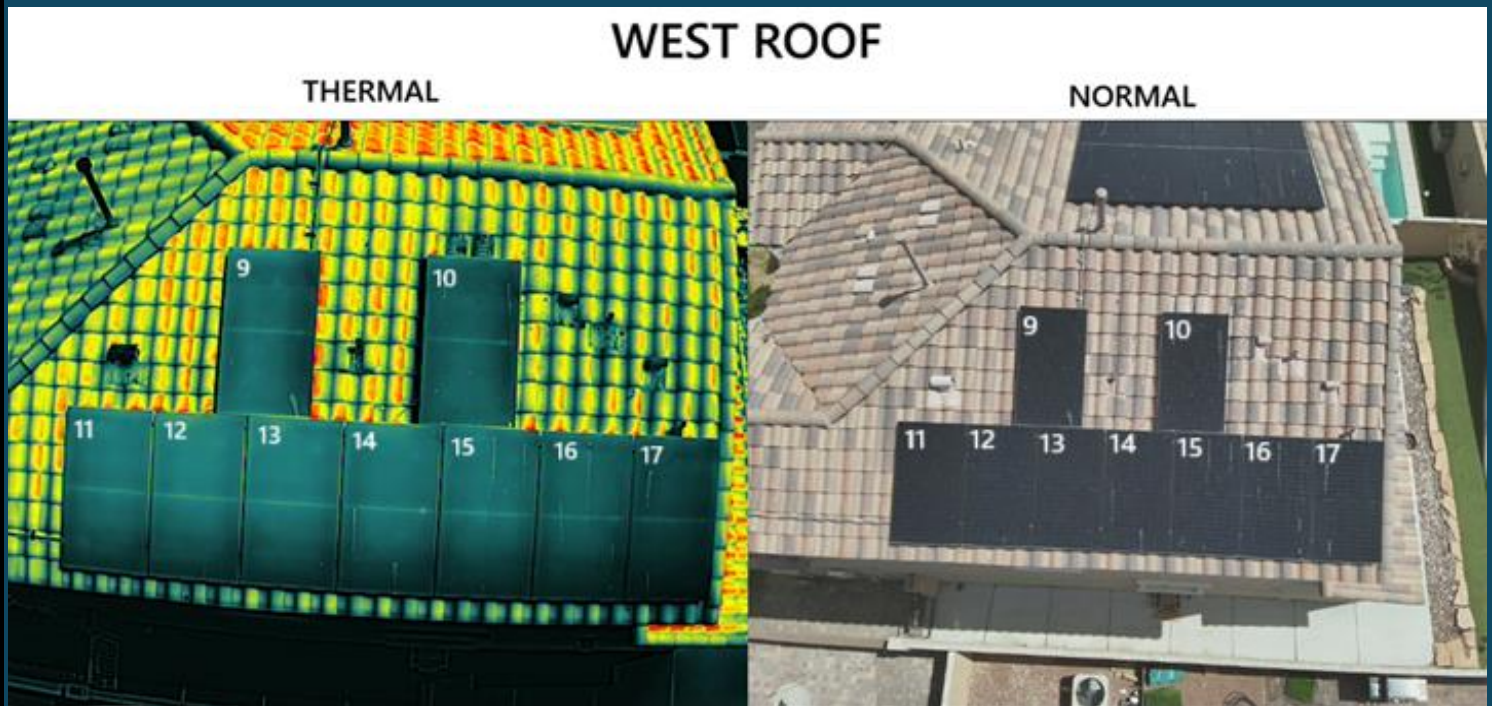
Aerial thermographic analysis of West roof shows an array of 9 vertically arranged (likely Half Cut style) panels. Minor dust and bird droppings are present as common. No problematic thermal signatures are visible.
